Solar Farm
Erosion
Rio Vista Plant
(lower field -
constructed in 2011)

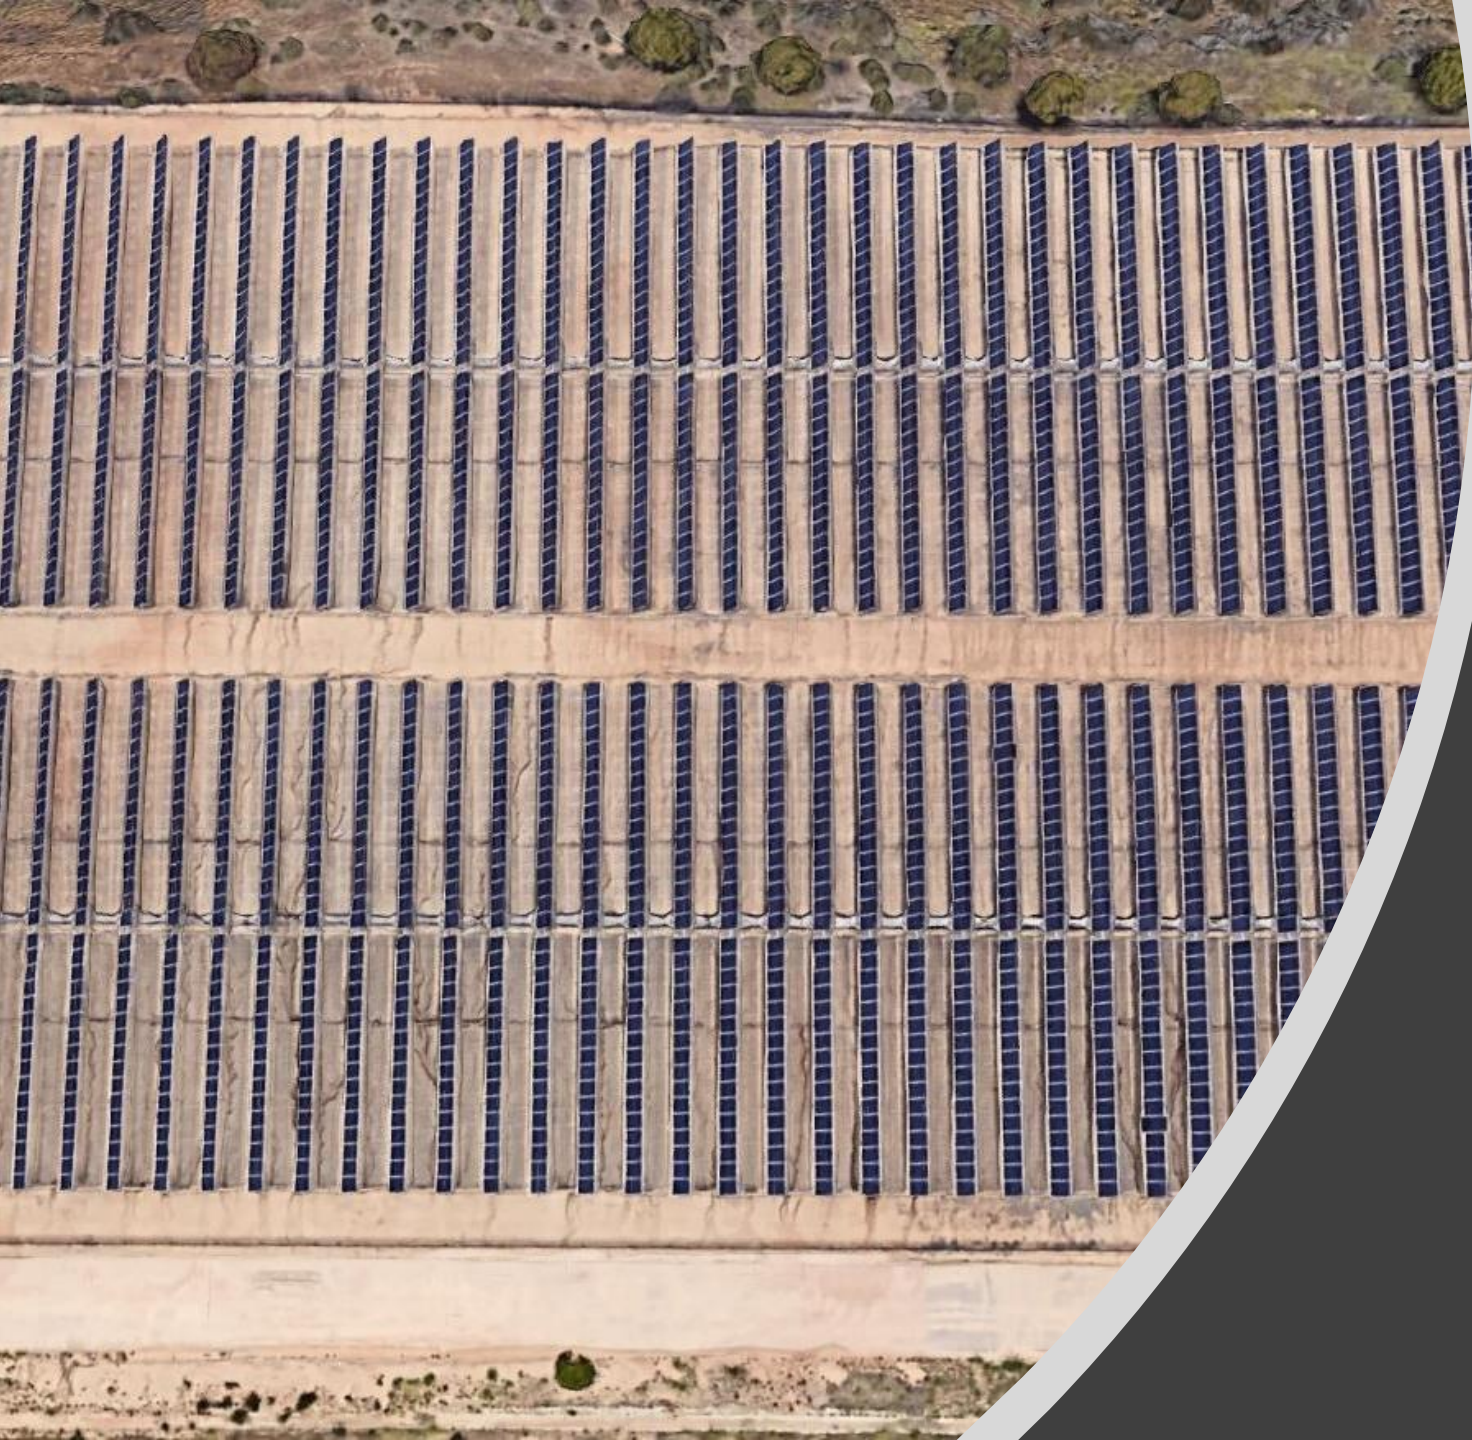
Possible Causes

- Erosion caused by soil not compacted properly
- Soil or terrain not graded properly
- Lack of wall containment
- Water not draining properly

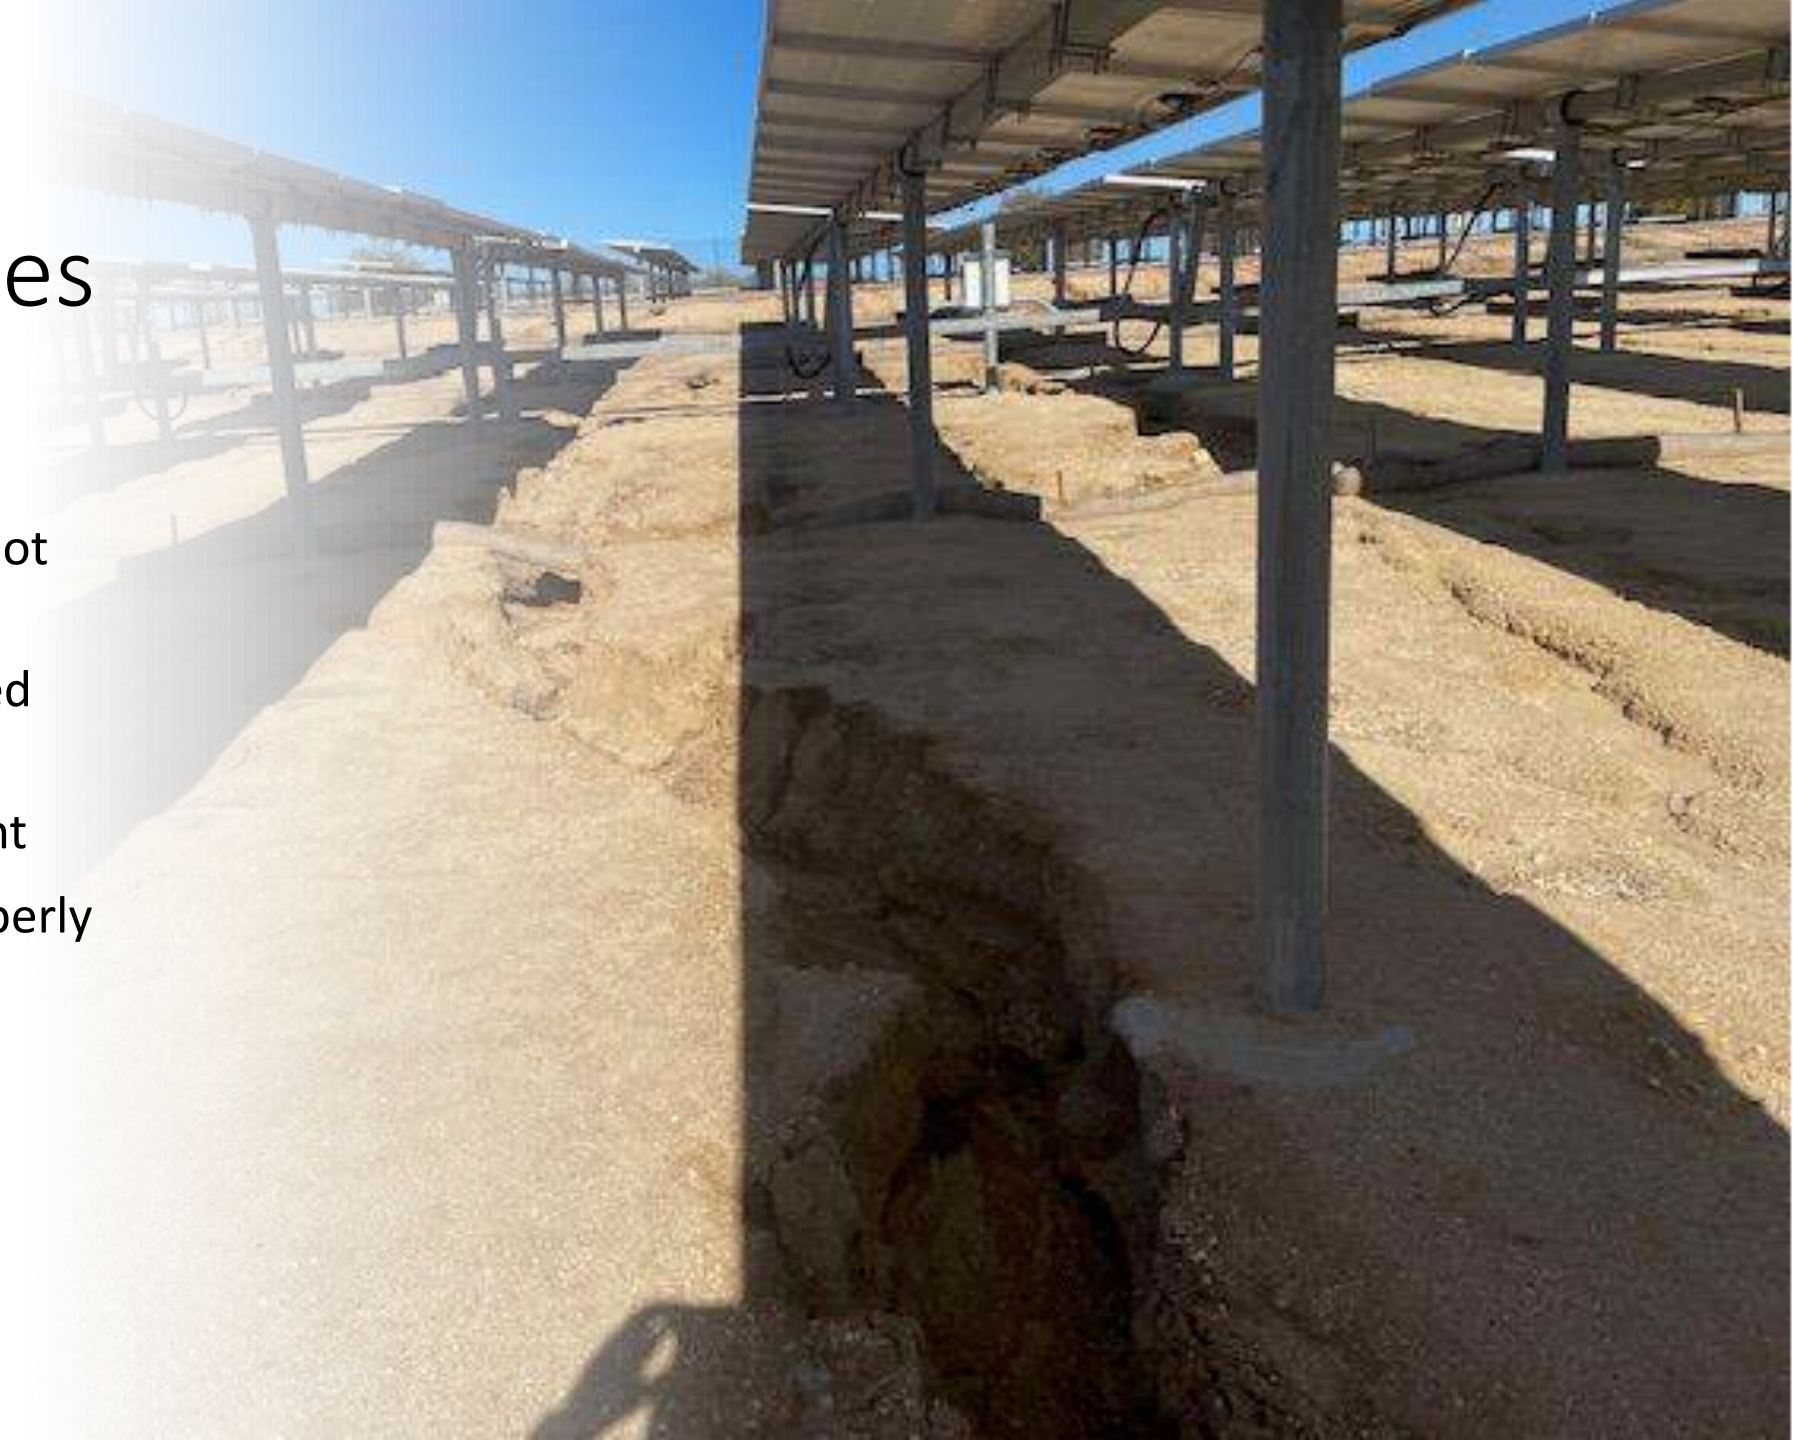
Extent of Damage

- 80% of field damaged by erosion
- Exposure to footings for solar panel poles
- Potential to have solar panels fall due to unstable soil

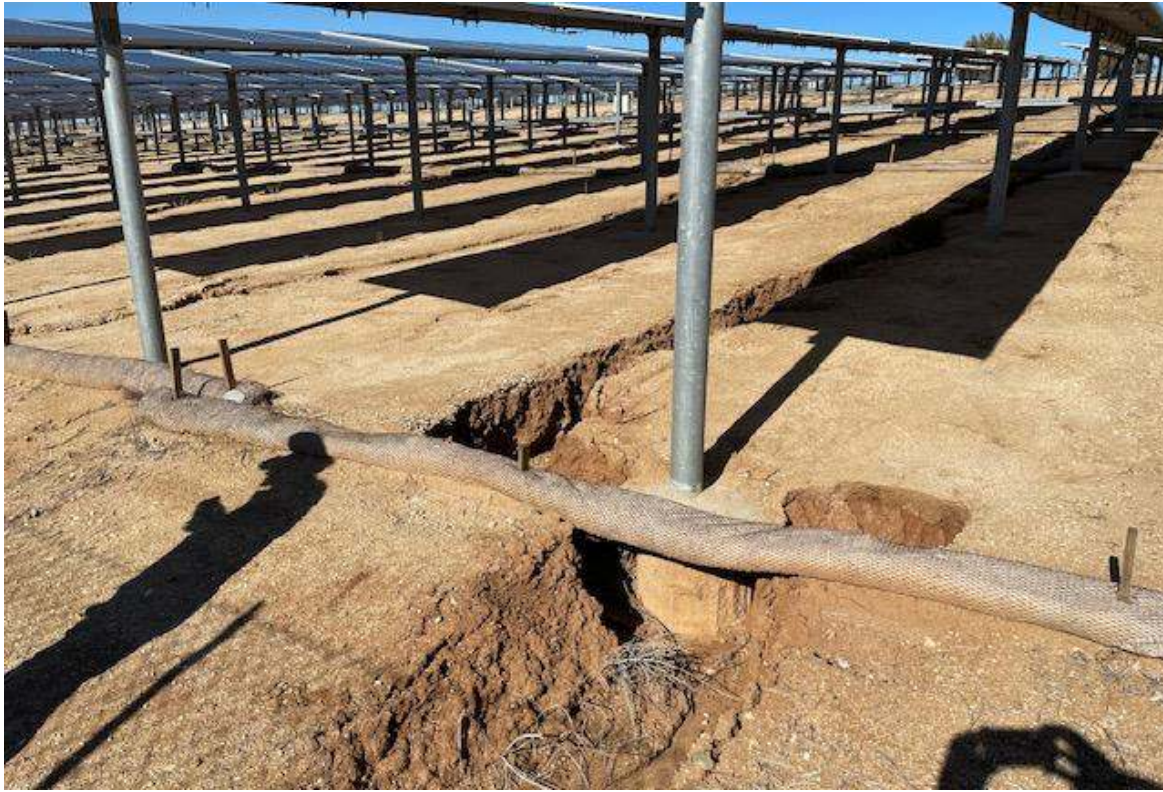
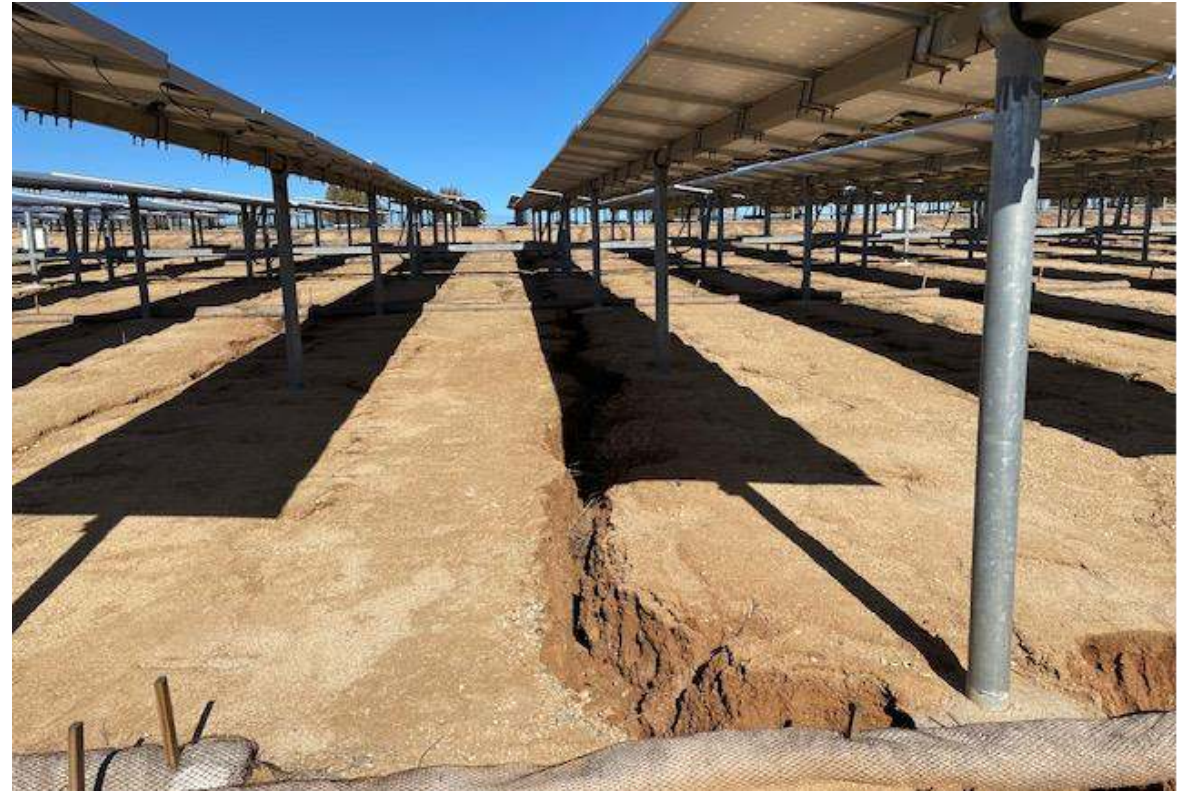
Extent of Damage

- 80 % of field damaged by erosion
- Crevices forming throughout the field

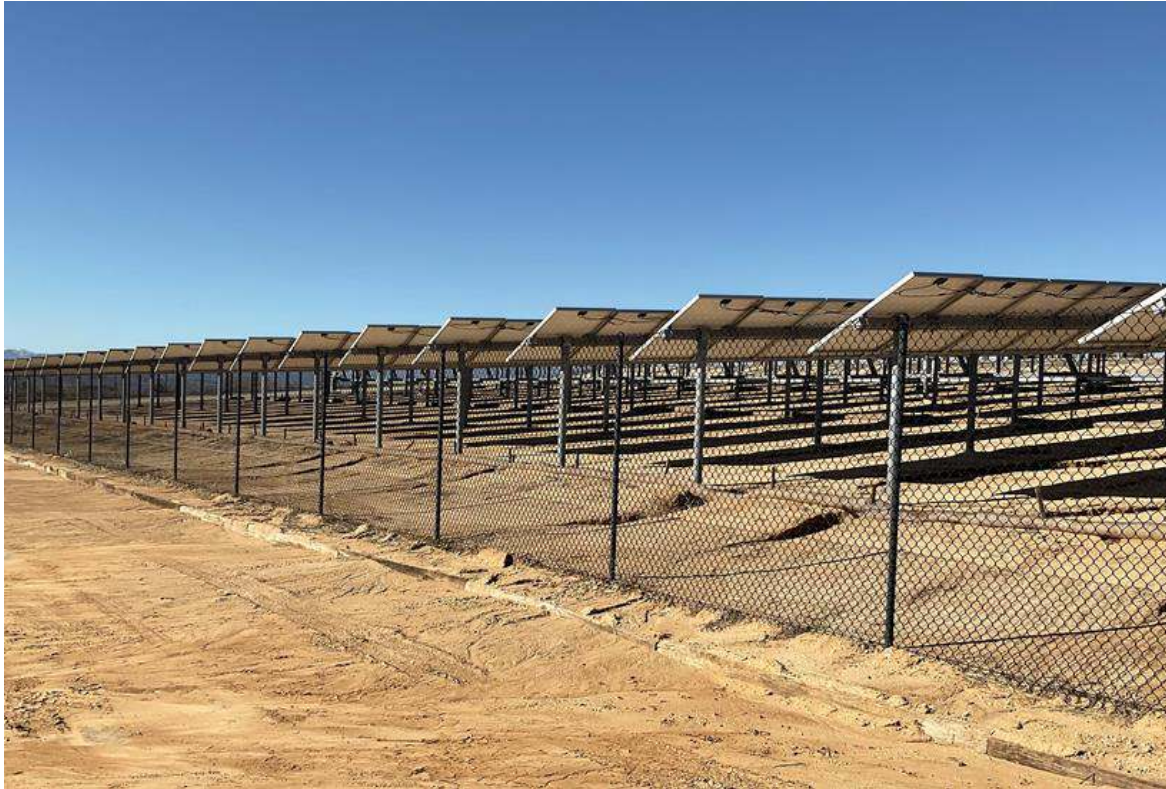
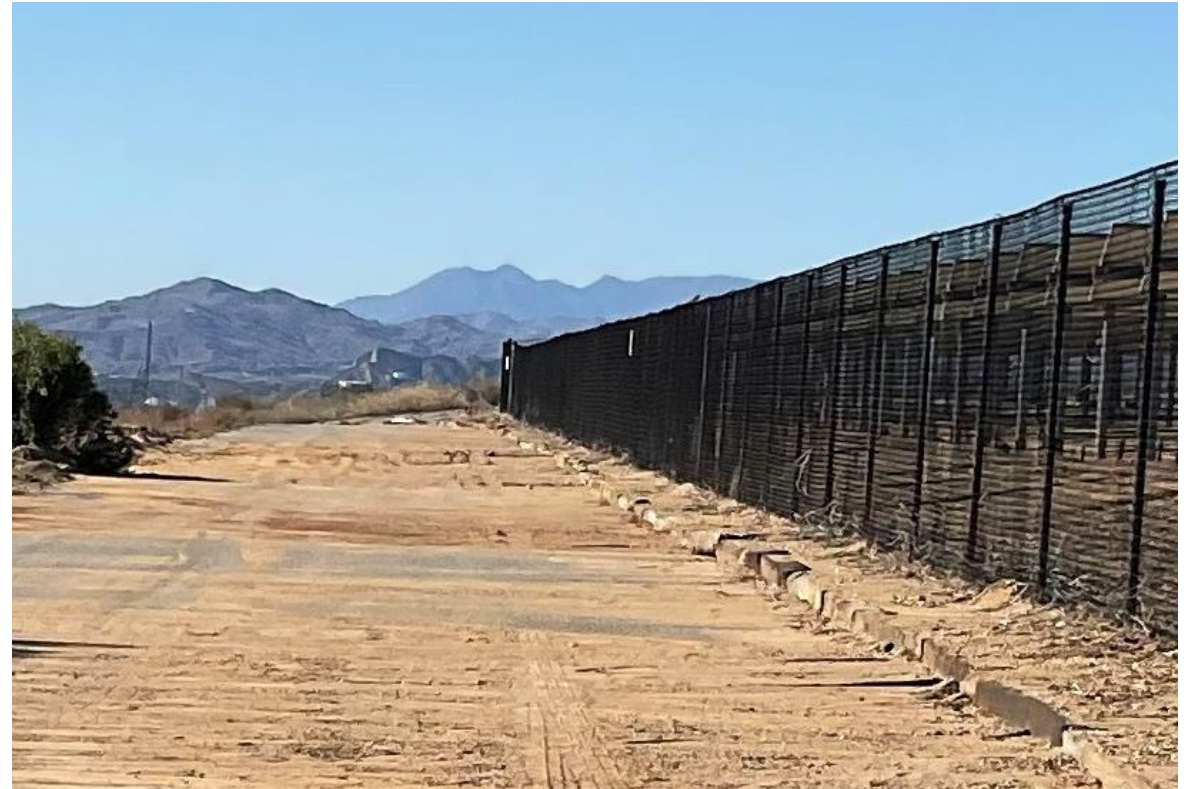
Road Muddy and Water Run Off

- Water run off causing muddy road
- Potential to block access to antenna and tank
